AD617603 HYDROFOIL MATERIALS RESEARCH PROGRAM
FINAL REPORT

PREPARED UNDER NAVY BUREAU
OF SHIPS, CONTRACT NObs-84593
INDEX NUMBER SF0130201
TASK 1705

Engineering Report 2-53100/5R-2179
21 March 1961 to 1 July 1965

Final Report 2-53100/5R-2179

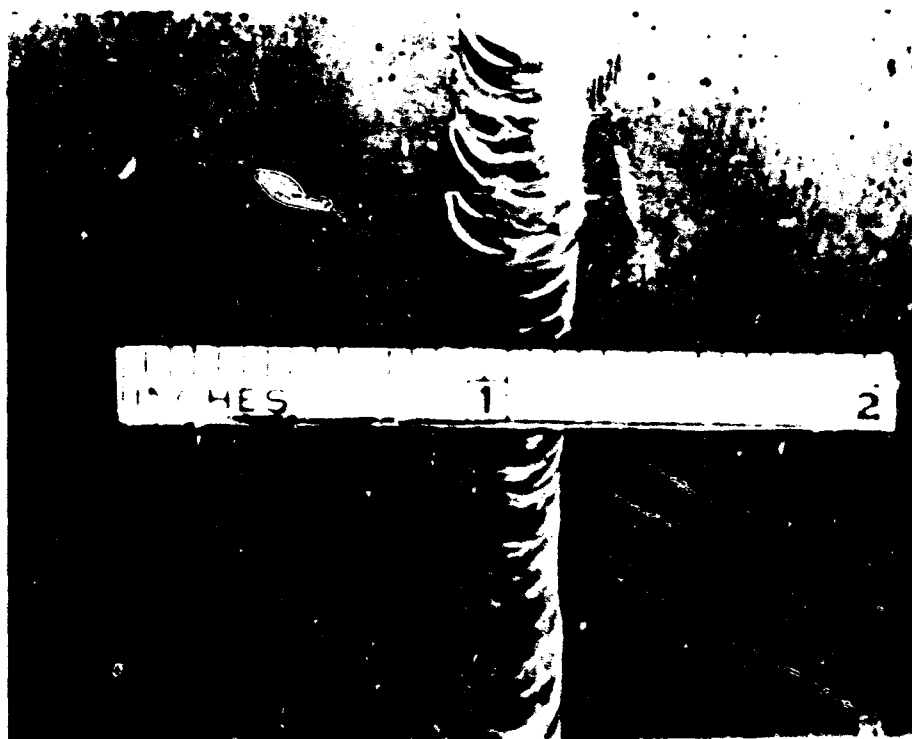
Figure 4.14 Unwelded and welded 2024-T3 Static Corrosion Specimens after sixth monthly removal. Left weld - heat treated, right weld - exposed as welded.
